National Transportation Safety Board

ERA22FA105

AIRWORTHINESS

Group Chair's Factual Report

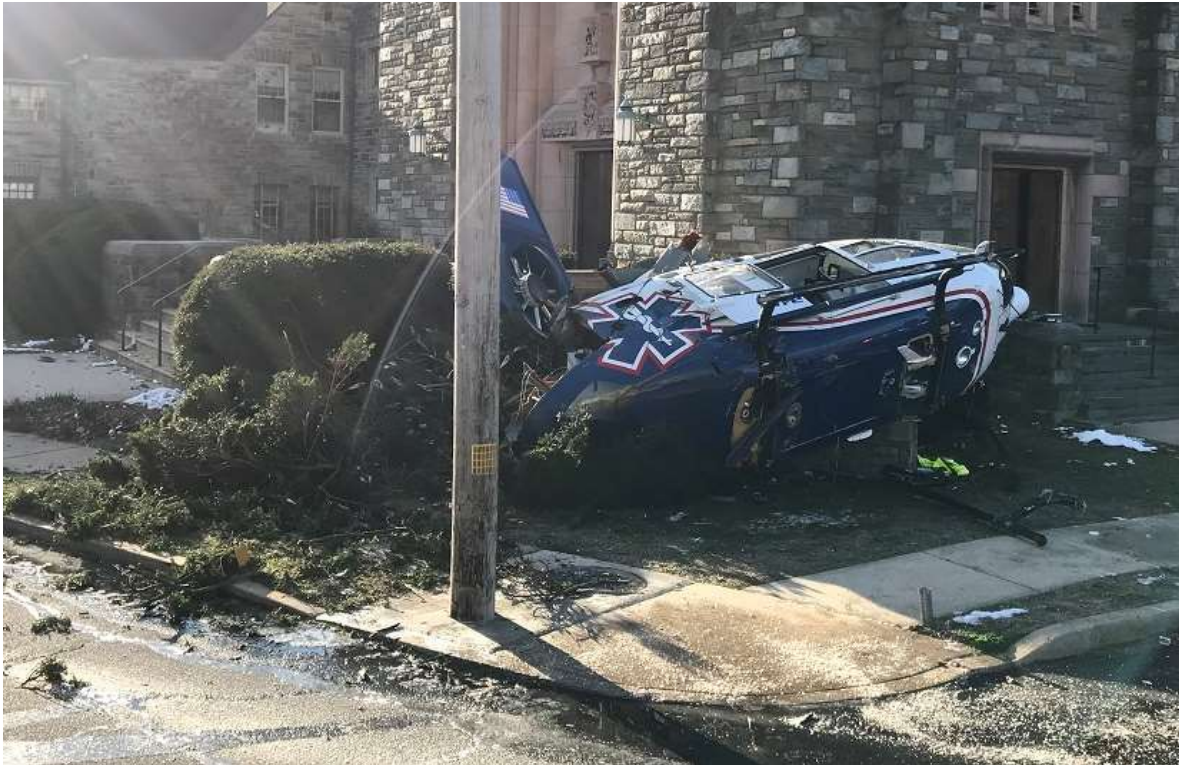
The helicopter impacted the ground and came to rest adjacent to a building (**Figure 1**). The helicopter had also impacted bushes immediately adjacent to the building as well as a metal wire and a traffic sign near the building. All wreckage was found in a compact area with no substantial debris trail.

Figure 1. The helicopter at the accident site. (Image courtesy of Airbus)

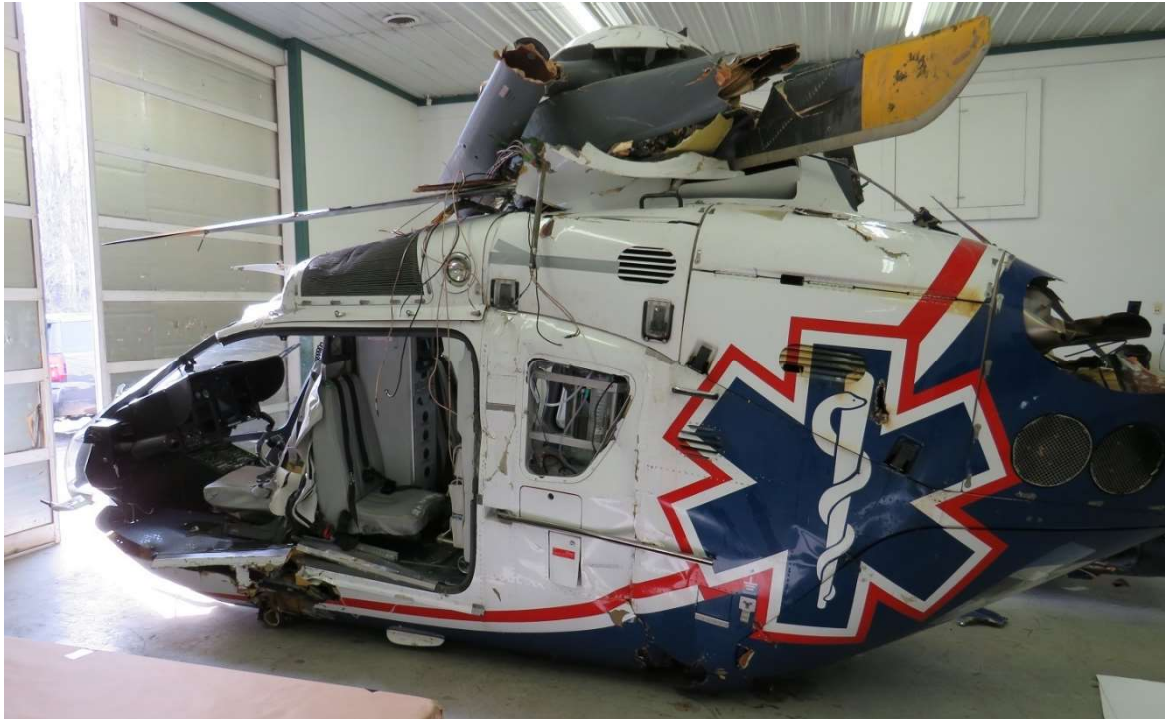
The main rotor hub remained attached to the main rotor shaft. The root ends of all four main rotor blades remained attached to the main rotor hub. The 'red' and 'yellow' main rotor blades had wrapped around the main rotor shaft and exhibited separation of its afterbody in various locations along the span of the blade (**Figure 2**). The 'green' main rotor blade was relatively straight but exhibited a chordwise fracture near its inboard end. The 'green' main rotor blade also exhibited separation of its leading edge abrasion strip and its trailing edge had opened and separated. The 'blue' main rotor blade had fractured and separated at its inboard end and exhibited separation of its afterbody about the midspan of the blade.

Figure 2. The 'red' and 'yellow' main rotor blades wrapped around the main rotor shaft. (Image courtesy of Air Methods)

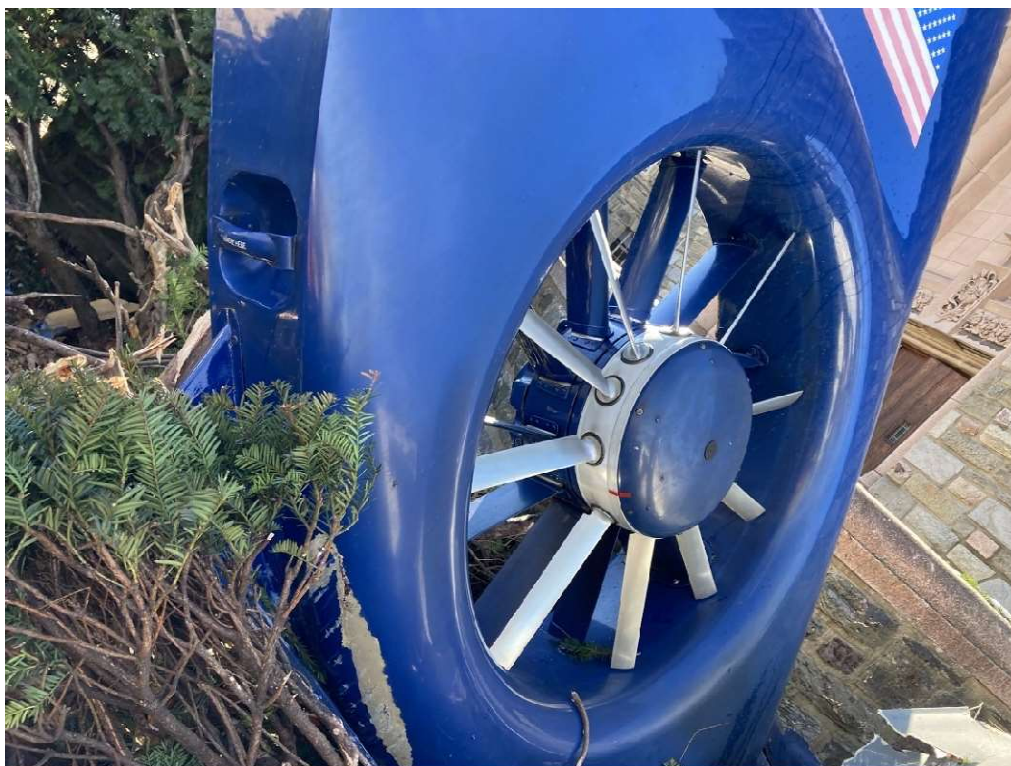
All 10 Fenestron blades remained installed and did not exhibit significant damage (**Figure 3**). The pitch change spider remained connected to all Fenestron blades. The flexible coupling at the forward end of the Fenestron drive shaft exhibited fragmentation. The forward section of the Fenestron drive shaft was

Figure 3. The Fenestron tail rotor at the accident site. (Image courtesy of Air Methods)

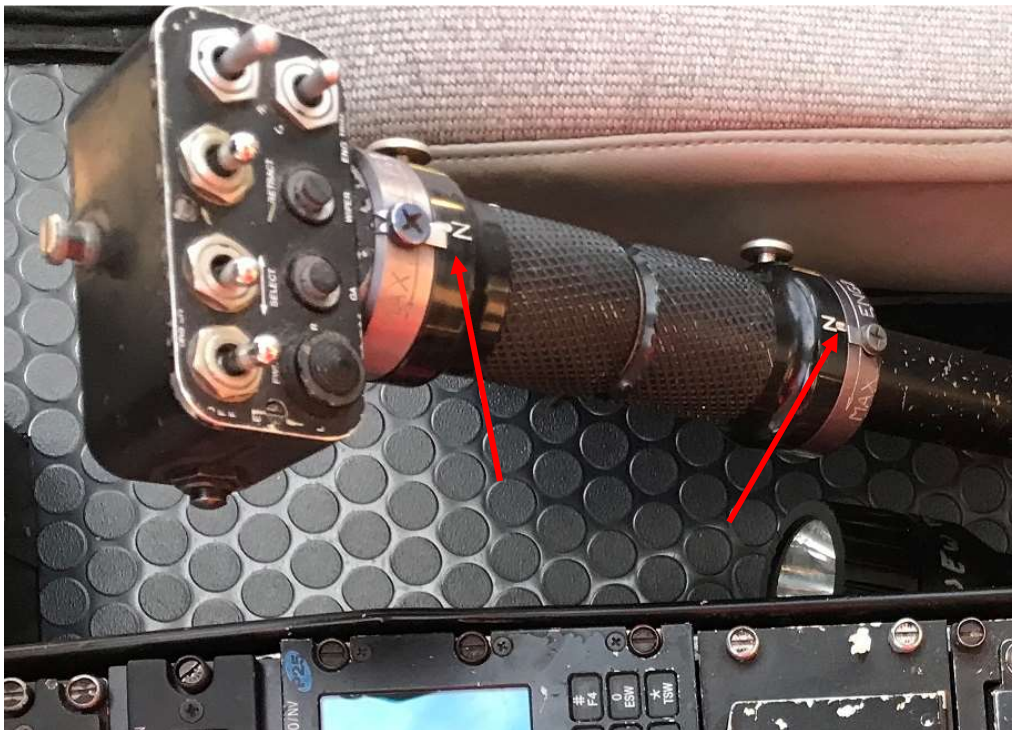
Figure 5. The red arrows point to the collective control-mounted engine twist grips in the "N" position. (Image courtesy of Airbus)

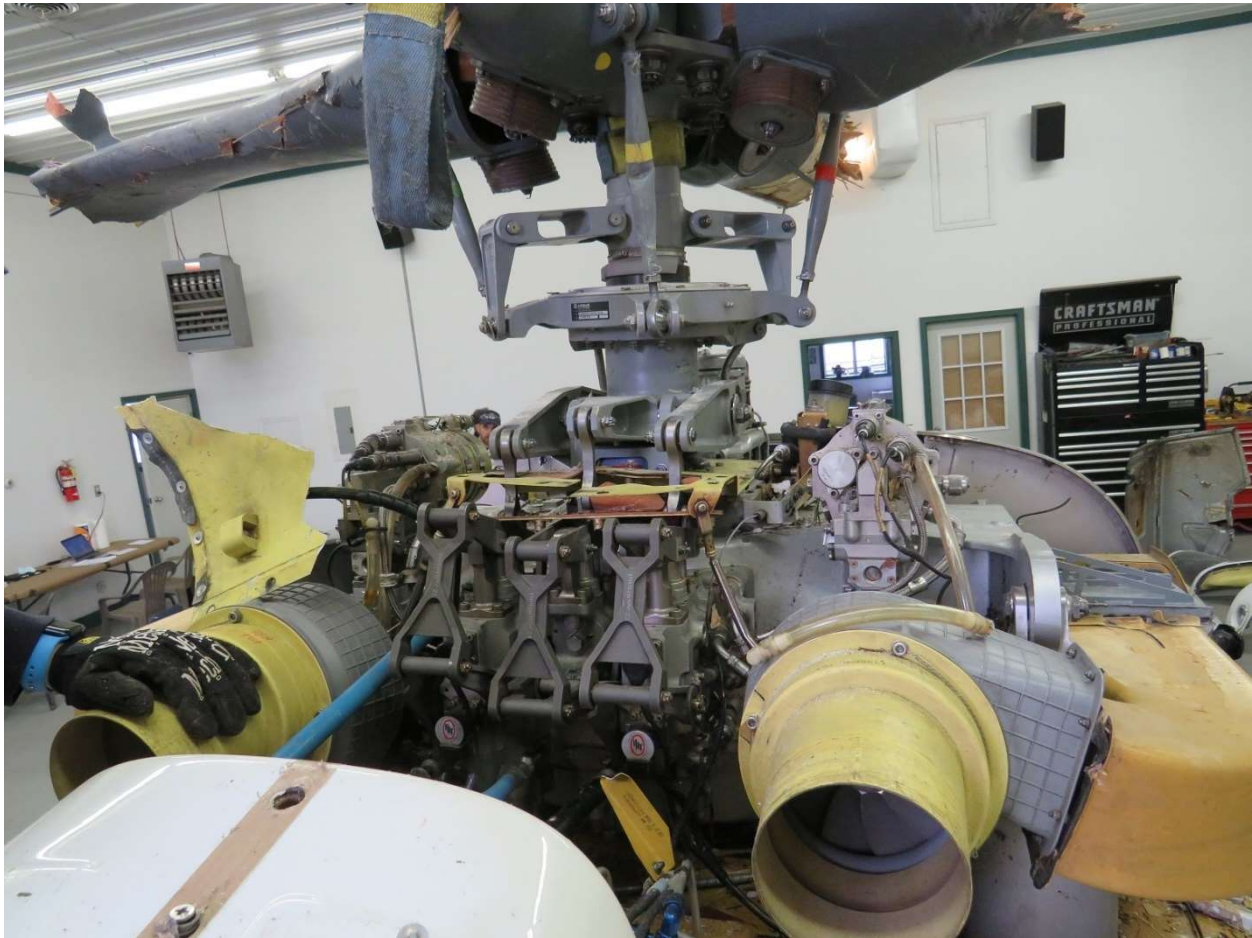
The pitch, roll, and collective MRAs remained installed as an assembly on the forward side of the main transmission housing (**Figure 6**). The electrical connections to the pitch and roll EHAs remained connected. The pitch SEMA and roll SEMA remained installed with no evidence of anomalous external damage. Both ends of the

Figure 6. The MRAs, mixing levers, and swashplate assembly. (Image courtesy of Air Methods)

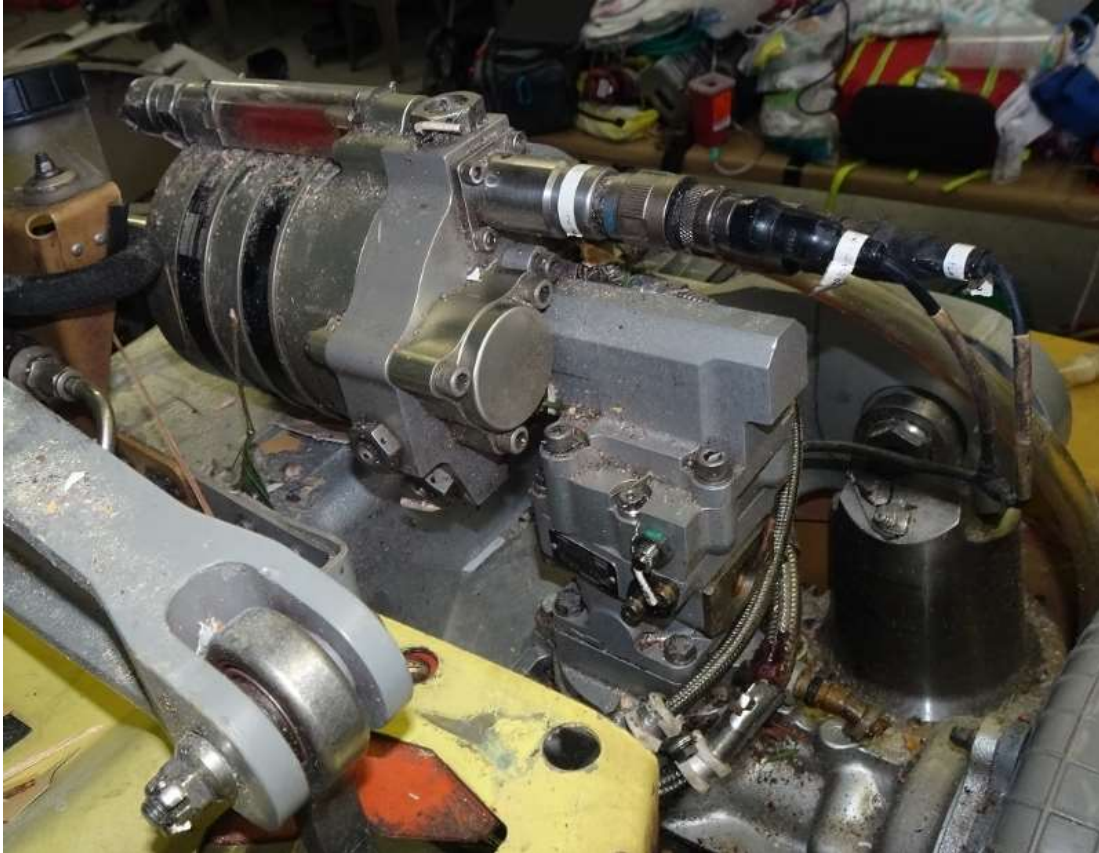
The No. 1 hydraulic pressure supply system remained installed on the airframe. The residual fluid was observed within the reservoir sight gauge (**Figure 7**). The solenoid and pressure switch plugs remained installed but it took less than two turns to remove these plugs from the reservoir housing. The hydraulic pressure line from the pump had fractured at the ferrule on the actuator-side of the line. The hydraulic return line remained intact. The hydraulic pressure and return lines were tight and exhibited no evidence of looseness. No residual hydraulic fluid was observed within either pressure or return lines after their removal. The hydraulic overflow line exhibited impact separation.

Figure 7. The No. 1 hydraulic pressure supply system.

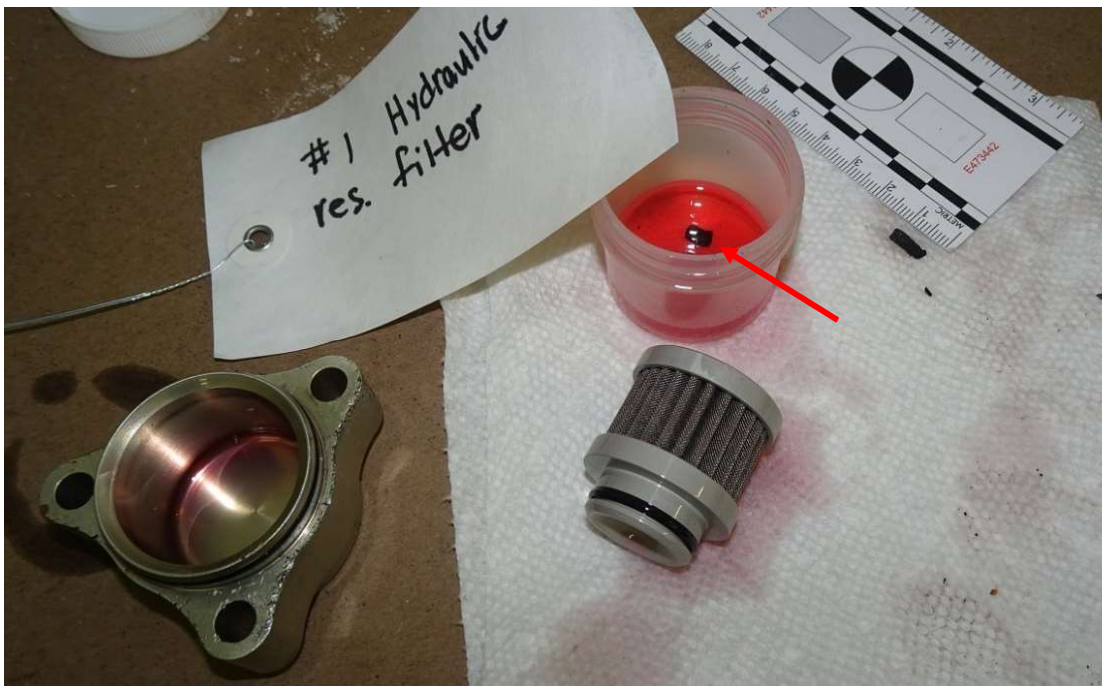
The hydraulic filter bowl was removed (with the filter element still residing within the pressure supply system housing) and several large pieces of black-colored debris was present within the residual fluid that drained during filter bowl removal, consistent with being present on the pre-filtration side of the filter element (**Figure 8**). The filter element was removed and exhibited no evidence of blockages or significant foreign material build up. Black-colored material was adhered to the hydraulic filter orifice on the surface that the filter contacts; this material was on the post-filtration side of the filter element (**Figure 9**). The drive splines for the No. 1 hydraulic pump were intact with no anomalous wear or damage present. Rotation of the main rotor resulted in a corresponding rotation of the splines for the No. 1 hydraulic pump pad.

Figure 8. The No. 1 hydraulic filter element, filter bowl, and debris (red arrow) collected from the pre-filtration side of the residual hydraulic fluid.

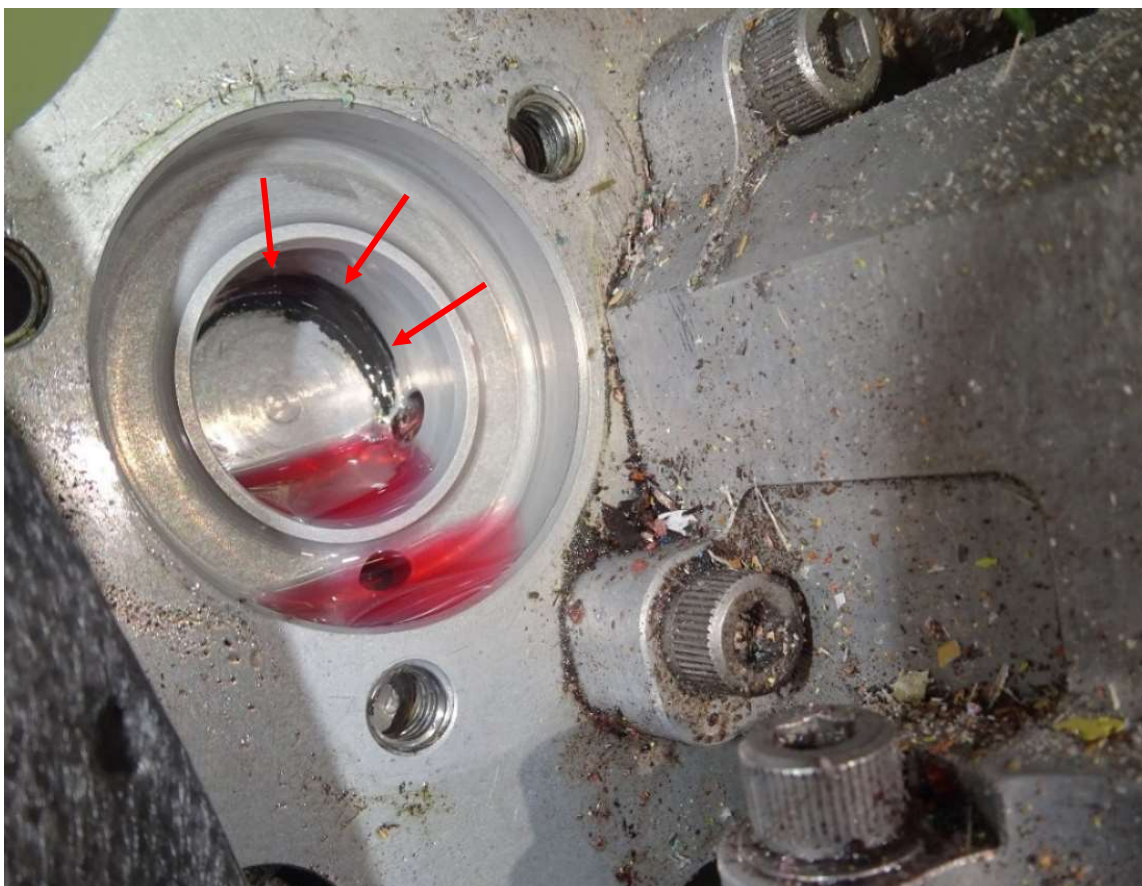
Figure 9. Red arrows point to the black-colored material adhered to the No. 1 hydraulic filter orifice.

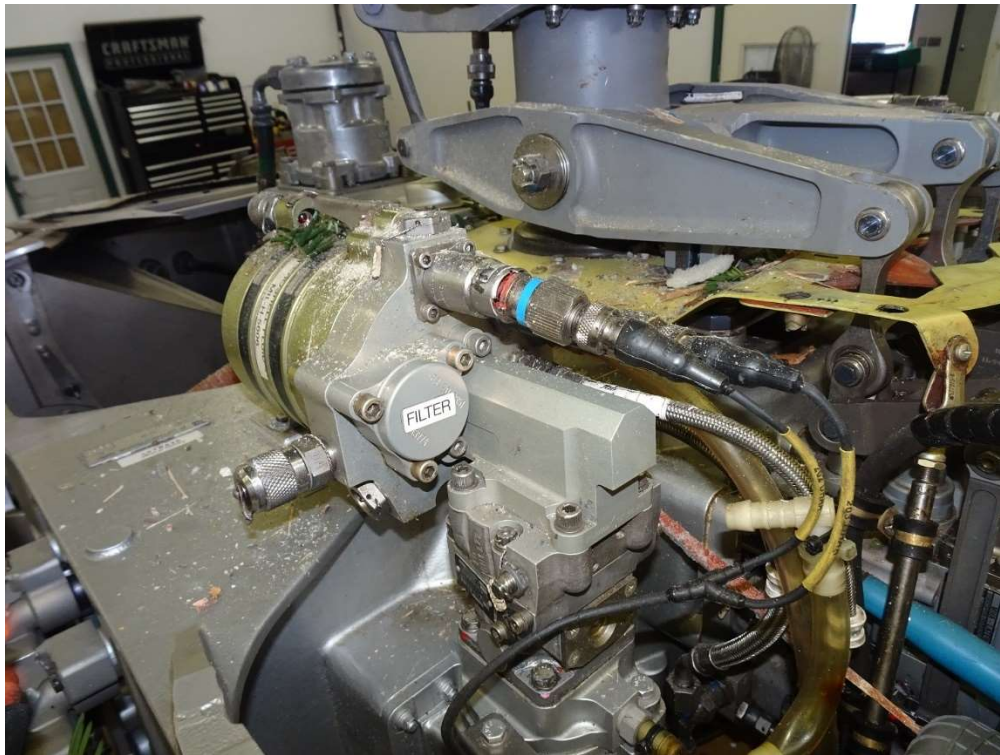
The No. 2 hydraulic pressure supply system remained installed on the airframe. The reservoir sight gauge had fractured and no residual fluid was present within the remnant sight gauge (**Figure 9**). The solenoid and pressure switch plugs remained installed and did not exhibit looseness. The solenoid plug was cocked to the left. The hydraulic pressure and return lines remained intact and installed. The hydraulic overflow line remained installed and did not contain residual hydraulic fluid.

Figure 9. The No. 2 hydraulic pressure supply system.

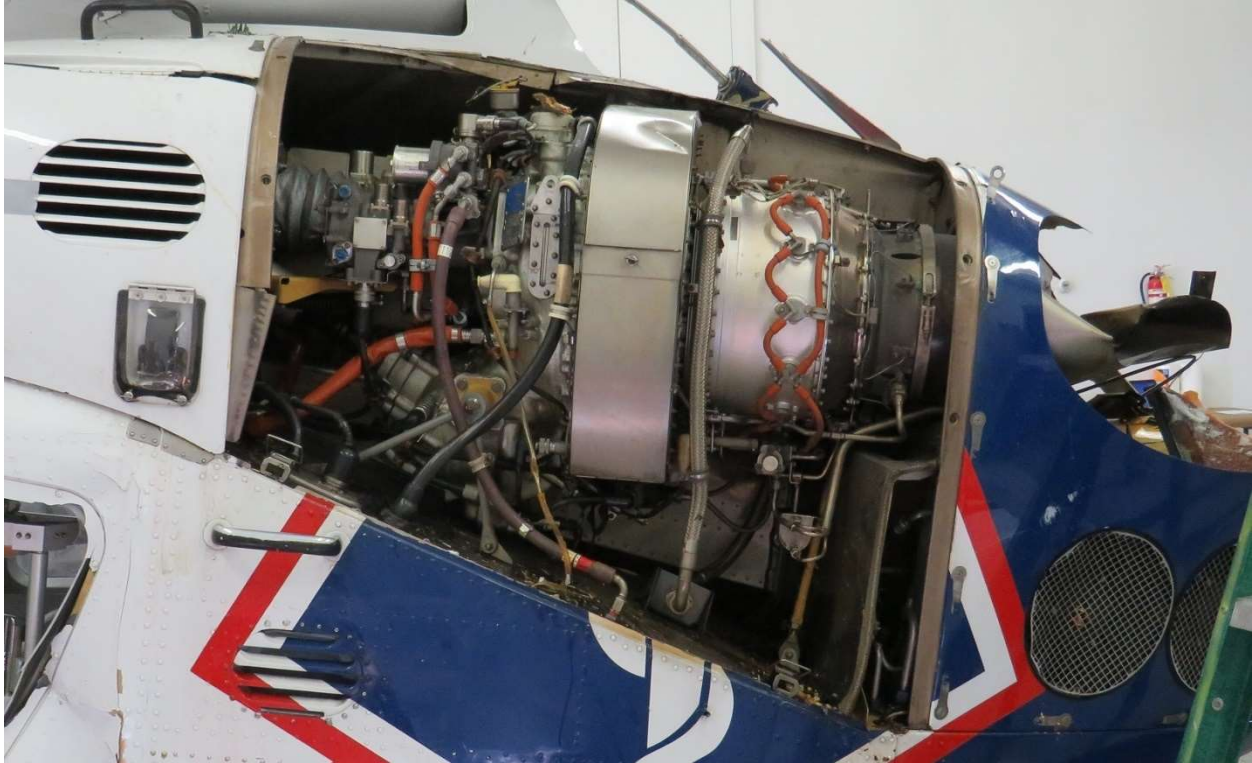
Both the Nos. 1 and 2 engines remained installed on the airframe (**Figures 10 and 11**). The No. 1 engine exhaust had deformed downward. The No. 2 engine exhaust had deformed inward, upward, and to the right. The vents of both Nos. 1 and 2 engine cowlings and their rubber drain hoses were both thermally damaged. However, no significant thermal damage was observed on the exterior casing of both

Figure 10. The No. 1 engine installed on the airframe. (Image courtesy of Air Methods)

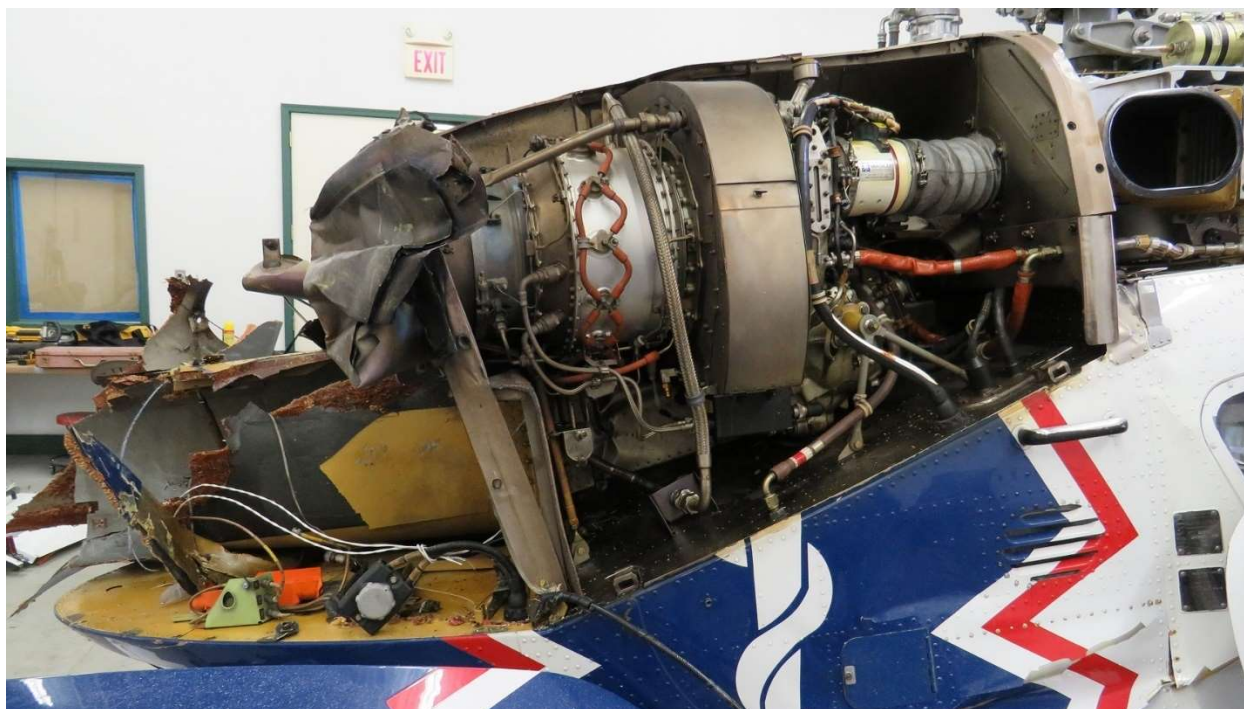
Figure 11. The No. 2 engine installed on the airframe. (Image courtesy of Air Methods)

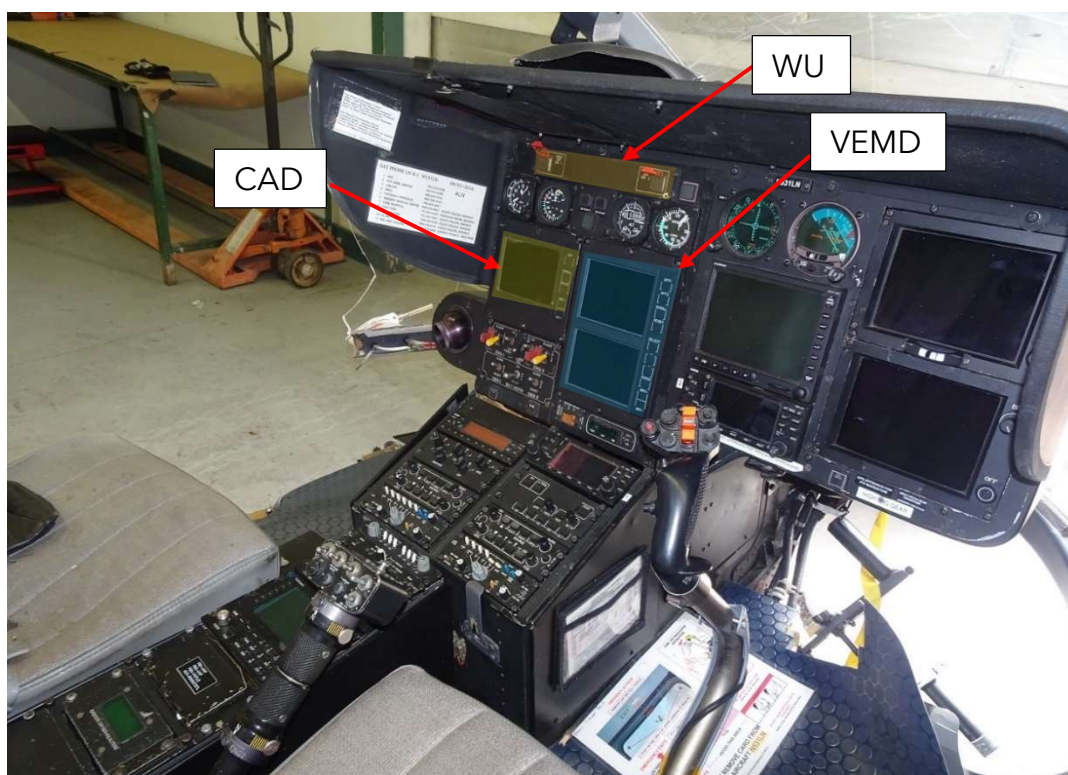
The VEMD, CAD, and WU remained installed in the cockpit instrument panel (**Figure 12**). The engine fuel emergency shutoff button on the left side of the WU had been activated.⁹ The engine fuel emergency shutoff button on the right side of the WU was found in the normal (not activated) position. Both engine control switches were found in the "off" position and the FADEC switches were in the "on" position. The battery master switch was found in the "off" position. The generator I and generator II switches were both in the "normal" position. The two transfer pump switches were in the "off" position.

Figure 12. The accident helicopter cockpit.

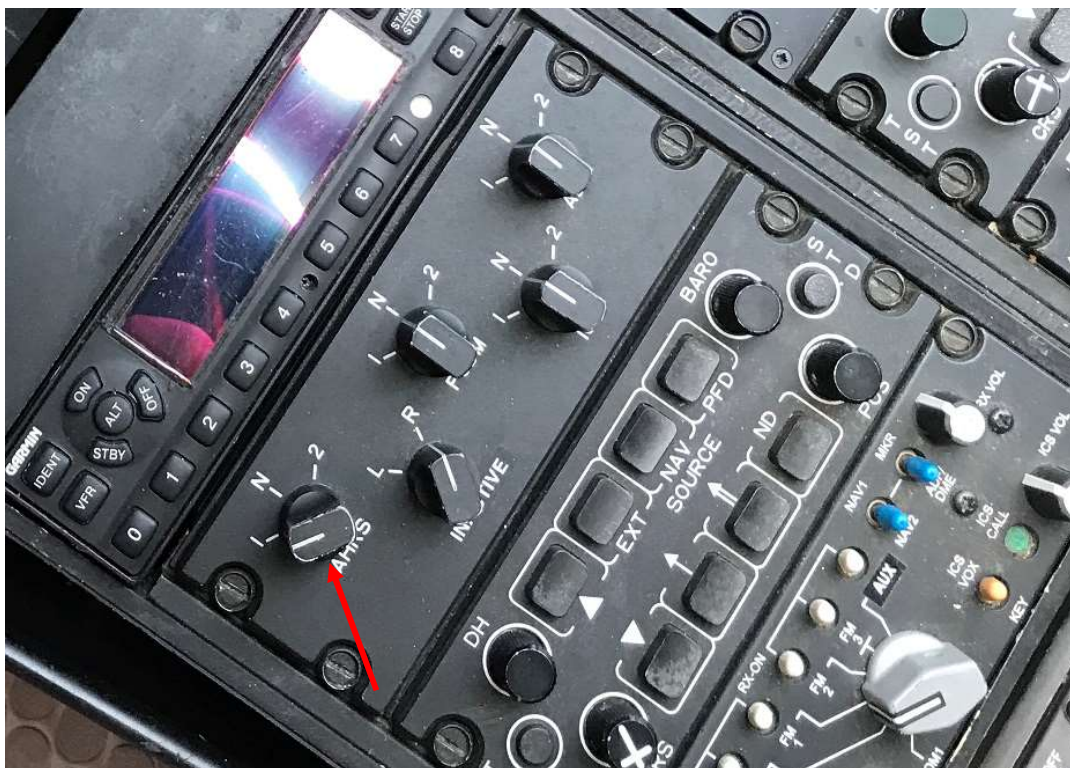
For the reconfiguration control unit (RCU) on the slanted console, the "AHRS" knob was found in the "1" position, the "FCDM" knob was found in the "N" position, the "ADC" knob was found in the "N" position, the "ICP" (instrument control panel) knob was found in the "N" position, and the "INACTIVE" knob was found in the "R" position (**Figure 13**). The autopilot mode selector remained installed on the slanted console and did not exhibit anomalous damage.

Figure 13. A view of the RCU. The red arrow points to the AHRS knob found pointing to "1". (Image courtesy of Air Methods)

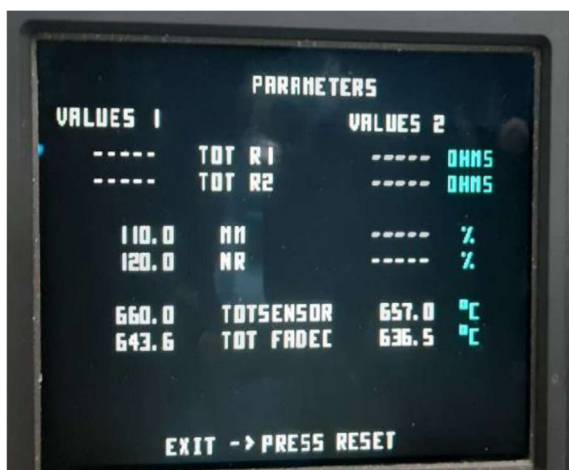
VEMD Position and Channel	Failure Entry #	Time (hh:mm:ss)	Select Recorded Parameters
Upper VEMD, left channel	1 (Figure 14)	00:48:08	Mast moment: 110.0% and no data Helicopter rotor speed (Nr): 120.0% and no data Turbine outlet temperature (TOT) sensor: 643.6°C and 636.5°C
Upper VEMD, left channel	7 (Figure 15)	00:48:08	N1 FADEC: 78.4% (engine 1) TOT FADEC: 606.1°C (engine 1) Torque FADEC: 0.0% (engine 1) N2 ²⁴ : 127.7% (engine 1) Collective pitch: 69.00% (engine 1)
Lower VEMD, right channel	7 (Figure 16)	00:48:08	N1 FADEC: 77.9% (engine 2) TOT FADEC: 596.5°C (engine 2)

Figure 14. Upper VEMD, left channel failure entry #1. (Image courtesy of Airbus)

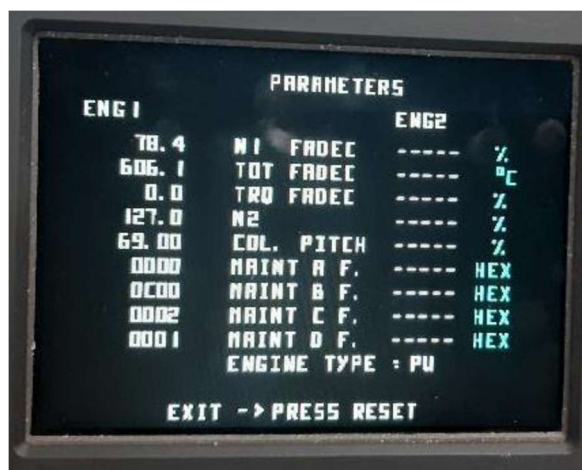
Figure 15. Upper VEMD, left channel failure entry #7. (Image courtesy of Airbus)

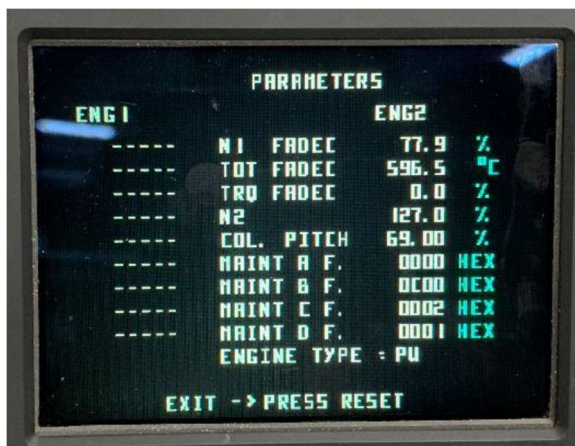
Figure 16. Lower VEMD, right channel failure entry #7. (Image courtesy of Airbus)

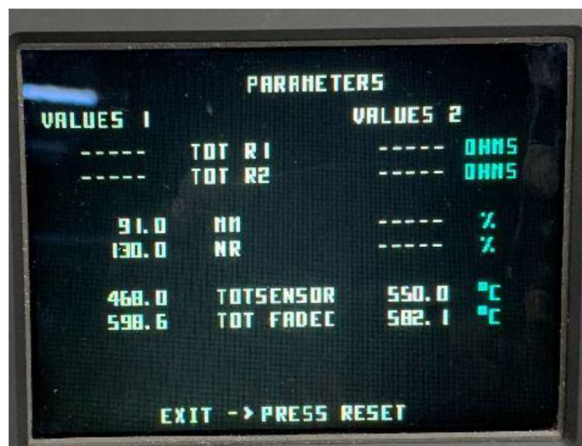
Torque FADEC: 0.0% (engine 2) N2: 127% (engine 2) Collective pitch: 69.00% (engine 2)
Lower VEMD, right channel	9 (Figure 17)	00:48:08	Mast moment: 91.0% and no data Nr: 130.0% and no data
Upper VEMD, left channel	12 (Figure 18)	00:49:45	Outside air temperature (OAT): -7.0°C and no data Main transmission oil pressure: 0.1 bar and no data

Figure 17. Lower VEMD, right channel failure entry #9. (Image courtesy of Airbus)

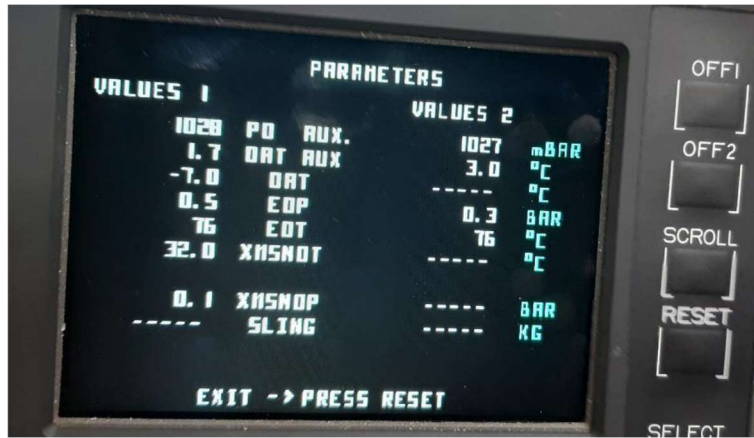
Figure 18. Upper VEMD, left channel failure entry #12. (Image courtesy of Airbus)

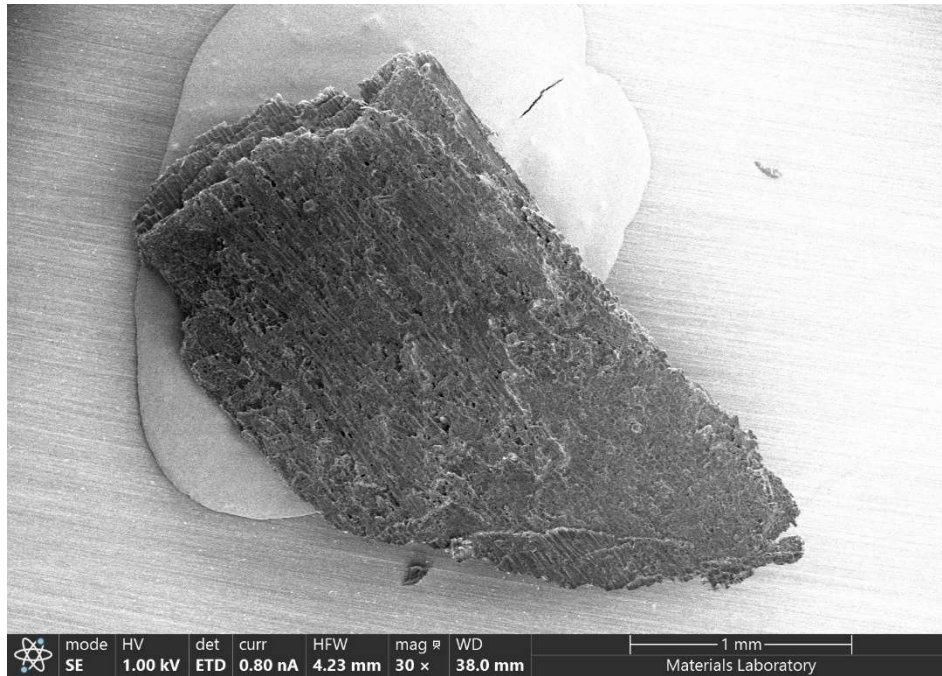
The black-colored debris found in the pre-filtration side of the filter was examined under a scanning electron microscope (SEM) at the NTSB Materials Laboratory in Washington, District of Columbia (DC). **Figure 19** shows the appearance of a representative sample of the black-colored debris under magnification in the SEM. Energy dispersive x-ray spectroscopy (EDS) analysis of the black-colored debris showed peaks in carbon and oxygen (**Figure 20**).

Figure 19. The black-colored debris from the No. 1 hydraulic filter bowl seen under magnification in the SEM.

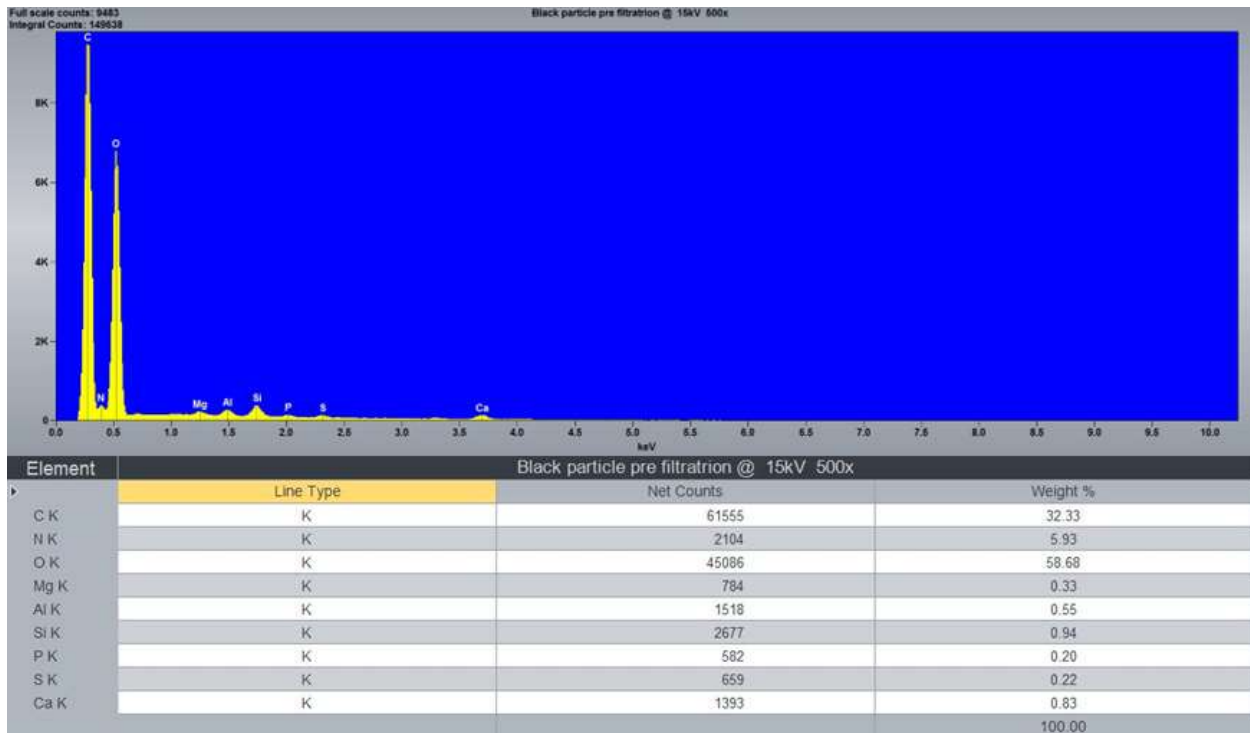
Figure 20. EDS analysis of the black-colored material found in the No. 1 hydraulic filter bowl.

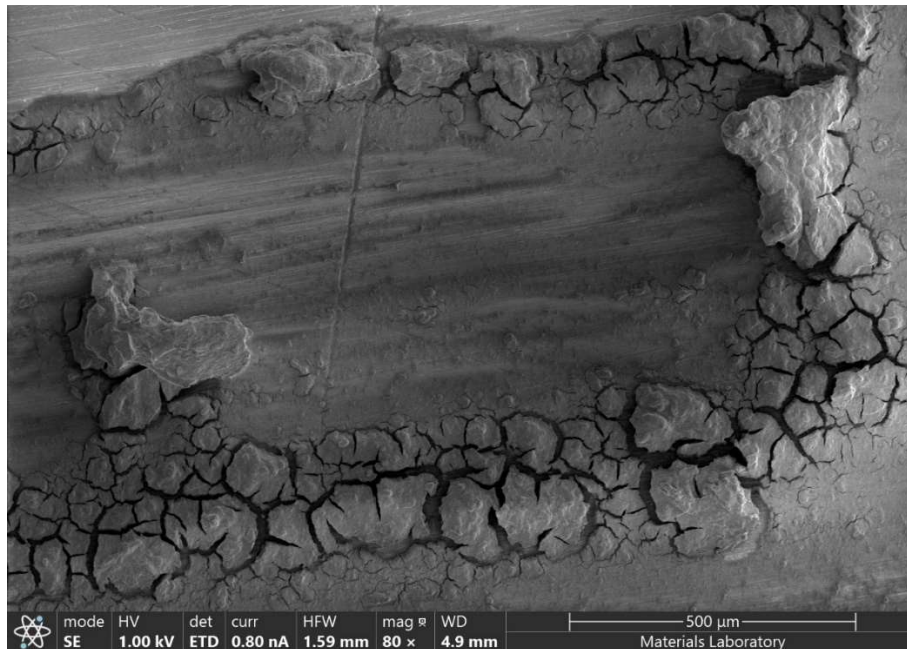
The black-colored material found in the post-filtration side of the filter orifice was also examined under a SEM at the NTSB Materials Laboratory. **Figure 21** shows the appearance of this material under magnification. EDS analysis of the black-colored material showed peaks in carbon, oxygen, copper, and zinc (**Figure 22**).

Figure 21. The black-colored material from the orifice of the No. 1 hydraulic filter seen under magnification in the SEM.

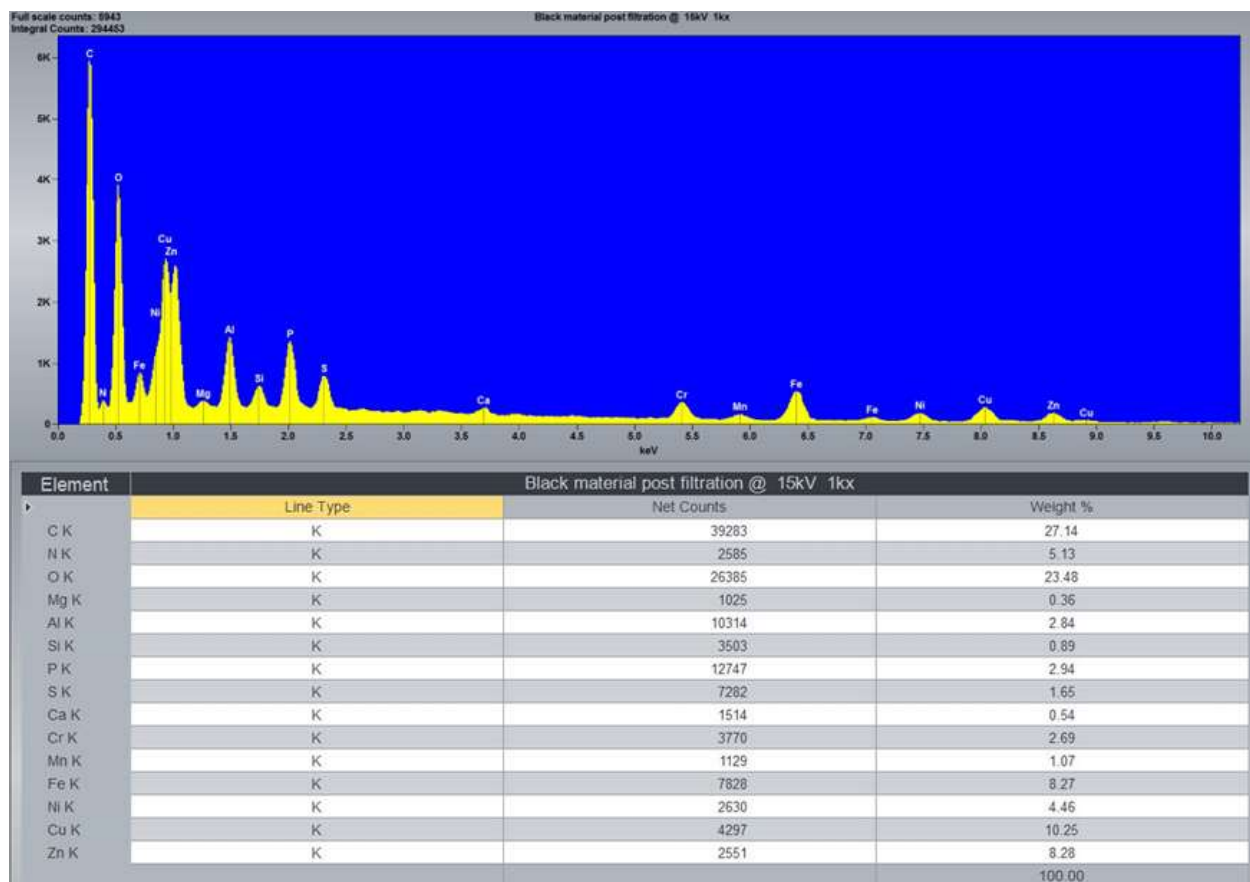
Figure 22. EDS analysis of the black-colored material from the orifice of the No. 1 hydraulic filter.

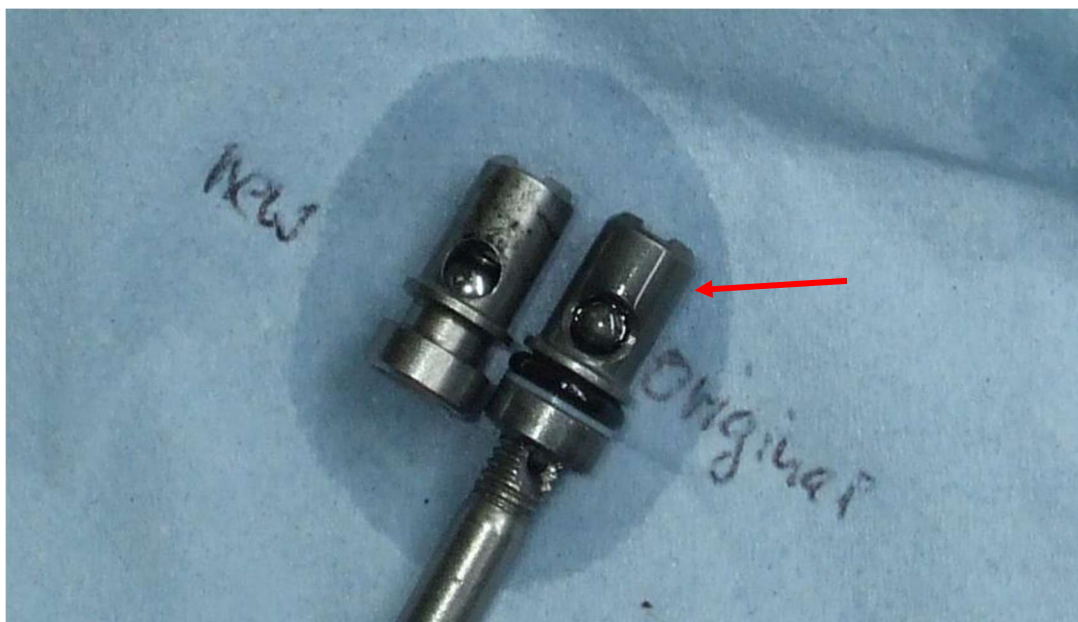
The longitudinal cyclic MRA was bench tested using the ATP as guidance. The actuator failed the system 1 drift rate extension and retraction tests. Troubleshooting determined that the system 1 pressure inlet check valve ball was stuck in the open position (**Figures 23 and 24**). The ball was able to be freed with a tap, after which the check valve behaved normally and was reinstalled. After reinstallation of the system 1 pressure inlet check valve, the longitudinal cyclic MRA passed the system 1 drift rate tests.

Figure 23. The accident longitudinal cyclic MRA's system 1 pressure inlet check valve (red arrow) showing the ball stuck in the open position. (Image courtesy of the BFU)

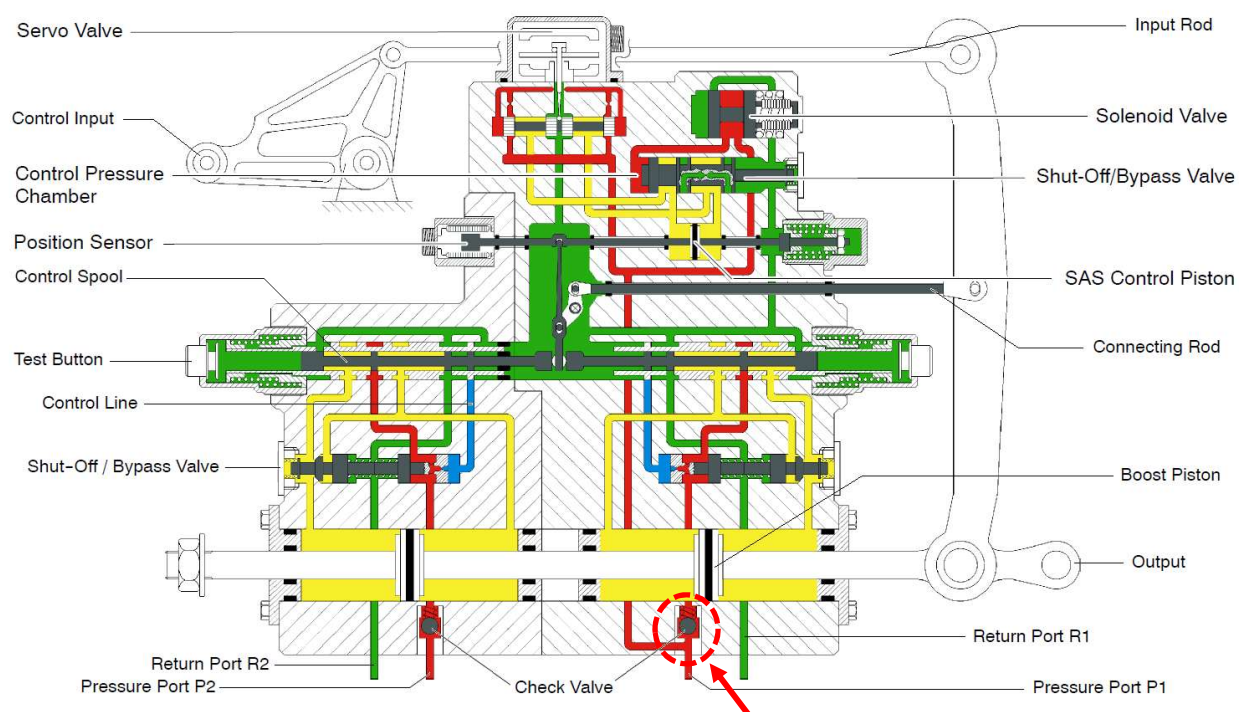
Figure 24. The red arrow and dashed oval indicates the location of the system 1 pressure inlet check valve. (Image courtesy of Airbus)
